## Femtosecond pulsed laser induced damage characteristics on Si-based multi-layer film

**Abstract:** In order to understand the ultrafast laser-induced damage mechanisms of typical imaging sensor's film structures, the damage characteristics of Si-based multi-layer films irradiated by a femtosecond pulsed laser were investigated, and the laser pulse fluence ranges and threshold conditions corresponding to various damage phenomena were evaluated. Si-based multi-layer films that were similar in structure of CCD were prepared by electron beam deposition. The damage characteristics of these films irradiated by a femtosecond pulsed laser with wavelength of 800 nm and pulse width of 100 fs under different pulse fluences and numbers were investigated using a metallurgical microscope. Experimental results showed that the laser-affected zone size increased linearly with pulse fluence in the range of 1.01 to 24.7 J/cm<sup>2</sup>. Surface damage caused by oxidation/amorphization, non-thermal ablation, and laser-induced plasma ablation could be observed in the laser irradiated zone, which tightly depended on the pulse fluence. Multi-layer damage could be observed and the damage probability

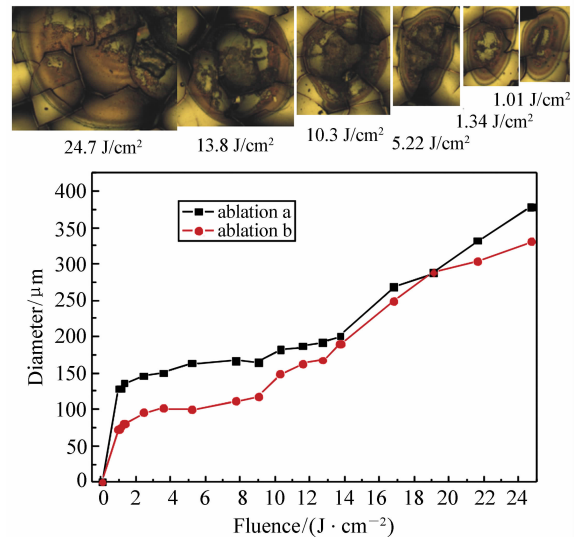
Fig. 4 Laser ablated zone sizes vary with pulse fluence

图4 烧蚀区域尺寸随脉冲能量的变化规律

In order to further study the evolution of the femtosecond laser ablation effect from laser energy fluxes, the long and short axis lengths of different laser energy flux irradiation damage areas were measured and plotted as curves, as shown in Fig. 4. The ablation zone size basically increased linearly with

the laser energy flux, a trend similar to that of the 532 nm nanosecond laser ablation polysilicon<sup>[19]</sup>. During the experiment, the minimum irradiation energy flux was  $0.076 \text{ J/cm}^2$  and no irradiation trace was observed corresponding to the irradiated surface, so the irradiation area was set to  $0 \text{ }\mu\text{m}$ . It can be seen from Fig. 4 that the changes in the long and short axes of the ablated region are basically the same and that there are two distinct growth trends of grown in the size of the ablated region as energy flux increases. For example: (1) In the range of  $0.076 - 1.01 \text{ J/cm}^2$ , the long axis of the ablation region increases rapidly from  $0 \text{ }\mu\text{m}$  to  $128 \text{ }\mu\text{m}$  (slope is 137); (2) in the range of  $1.01 - 24.7 \text{ J/cm}^2$ , the long axis of the ablated region increases from  $128 \text{ }\mu\text{m}$  to  $377 \text{ }\mu\text{m}$  (slope is 9.48). The difference in slope is a result of the spatial distribution of the pulse energy. The output waveform of the Ti:Sapphire femtosecond laser is generally quasi-Gaussian and the spatial distribution of the energy will dictate the morphology of the ablation in the film (including the ablation depth) or the damage effect. Ultra-laser energy flux irradiation experiments on the polished single crystal silicon surface (experimental results not shown) show that in the range of  $0.022 - 1.24 \text{ J/cm}^2$ , single pulse irradiation can only form a small diameter of  $7 - 100 \text{ }\mu\text{m}$  in the center of the spot. At a laser energy flux greater than  $1.24 \text{ J/cm}^2$ , the ablation effect can be observed gradually increasing on the irradiated surface (slope of 17.4). Comparing the results of single crystal silicon irradiation experiments, it can be inferred that in the range of  $0.076 - 1.01 \text{ J/cm}^2$ , oxidation and/or amorphization play a dominant role in the damage effect of Si-based multi-layer film materials; while within the  $1.01 - 24.7 \text{ J/cm}^2$  range, laser ablation plays a dominant role in material damage effects. According to the damage threshold definition<sup>[20-21]</sup>, the maximum laser energy flux at which no damage is observed and the average of the minimum laser

energy flux at which damage is observed can be taken as the damage threshold. The surface damage threshold under the current conditions of this experiment can be calculated to be  $0.543 \text{ J/cm}^2$ , which is equivalent to the damage threshold of the femtosecond laser for single crystal silicon reported in other literature<sup>[11,13]</sup>.

In addition, as the laser energy increases, the ablated region gradually become more circular and the laser damage and ablated regions gradually grow, even exceeding the size of the spot. During the laser irradiation experiment, it was found that when the single pulse energy exceeds  $6.24 \text{ J/cm}^2$ , plasma flash can be detected, which then becomes stronger as the energy is increased. This phenomenon is basically synchronous with the gradual rounding and enlargement of the damaged area observed by the microscope. Therefore, by comparing the effects of different laser energy flux damage, it is deduced that in the range of  $1.01 - 6.24 \text{ J/cm}^2$ , the main portion of Si-based multi-layer film damage is due to the absorption of non-thermal laser energy; in the range of  $6.24 - 24.7 \text{ J/cm}^2$ , this is mainly caused by laser-induced plasma ablation damage.

为进一步研究飞秒激光烧蚀效应随激光能量通量的演化规律,测量了不同激光能量通量辐照损伤区域的长轴和短轴长度,并绘制成曲线,如图4所示。烧蚀区域尺寸基本随激光能量通量线性增长,这一趋势与  $532 \text{ nm}$  纳秒激光烧蚀多晶硅的实验结果相似<sup>[19]</sup>。实验过程中,最小辐照激光能量通量为  $0.076 \text{ J/cm}^2$ ,对应辐照表面观察不到任何辐照痕迹,因此设其辐照区域尺寸为  $0 \text{ }\mu\text{m}$ 。从图4中可以看出,烧蚀区域长短轴尺寸变化基本一致,烧蚀区域尺寸随着能量通量增加存在两个明显不同的增长趋势,即,(1)在  $0.076 \sim 1.01 \text{ J/cm}^2$  范围内,烧蚀区域长轴从  $0 \text{ }\mu\text{m}$  快速增大到  $128 \text{ }\mu\text{m}$  (斜率为 137);(2)在  $1.01 \sim 24.7 \text{ J/cm}^2$  范围内,烧蚀区域长轴从  $128 \text{ }\mu\text{m}$  增大到  $377 \text{ }\mu\text{m}$  (斜率为 9.48)。烧蚀区域尺寸增长的斜率不同是由脉冲能量的空间分布所致,钛宝石飞秒激光的输出波形一般为准高斯型,其能量的空间分布将主导薄膜烧蚀的形貌(包括烧蚀深度)或损伤效应。对抛光单晶硅表面更加细致的低激光能量通量辐照实验表明(结果未显示在文中),在  $0.022 \sim 1.24 \text{ J/cm}^2$  范围内,单脉冲辐照仅能在光斑中心位置形成轻微的直径  $7 \sim 100 \text{ }\mu\text{m}$  的氧化/无定形化(斜率为 329)区域;激光能量通量大于  $1.24 \text{ J/cm}^2$ ,才能在辐照表面观察到随辐照激光能量通量增强而逐渐明显的烧蚀效应(斜率为 17.4)。对比单晶硅辐照实验结果可推测,在  $0.076 \sim 1.01 \text{ J/cm}^2$  范围内,氧化和/无定形化在硅基多层膜材料损伤效应中占主导作用;而在  $1.01 \sim 24.7 \text{ J/cm}^2$  范围内,激光烧蚀在材料损伤效应中占主导作用。根据损伤阈值定义<sup>[20-21]</sup>,可取未观察到损伤的最大激光能量通量和观察到损伤的最小激光能量通量的平均值作为损伤阈值,则可计算出本次实验在现有条件下的表面损伤阈值  $0.543 \text{ J/cm}^2$ ,这一数值与其他文献报道的飞秒

烧蚀破坏。同一块薄膜,光斑越大,光斑内包含的缺陷数越高,越容易引起破坏。在本实验中,综合图 4 和图 6 中烧蚀区域尺寸和应力损伤概率随激光能量通量的变化规律可以发现,两者的变化趋势和阈值范围基本相同,进一步证实应力破坏概率与烧蚀区域尺寸存在明显的对应关系。

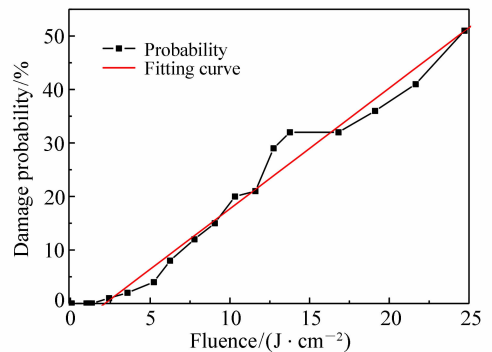
Fig. 6 Stress-induced damage probability varies with pulse fluence

图 6 应力损伤概率随激光能量通量的变化规律

As the energy flux of the irradiated laser decreases, the area and probability of exfoliation decrease. By recording the number of times the sheet peels in 100 irradiation points, the variation of the damage with respect to the laser energy flux was calculated, as shown in Fig. 6. It can be seen from Fig. 6 that the laser energy flux is in the range of  $2.42 - 24.7 \text{ J/cm}^2$ , the stress damage probability increases linearly with the laser energy flux and the damage probability increases from 1% to 51%. Re-

ferring to the Optical Surface Laser Damage Threshold Test Method (GB/T 16601-1996), the threshold for stress damage in the Si-based multi-layer film using a femtosecond laser single pulse under pre-existing conditions can be calculated to be  $2.16 \text{ J/cm}^2$ . Previous studies have shown that there is a probable relationship between the destruction of the film and the size of the laser beam spot. The larger the spot, the greater the probability of destruction, and vice versa<sup>[20]</sup>. The effect of the spot on film destruction is related to the impurities and defects of the film. A defect is more likely to absorb laser energy, resulting in an uneven distribution of temperature or stress in the spot, which is ideal for ablation damage. For identical films, the larger the spot size, the higher the number of defects contained in the spot, and the more likely there is to be damaged. In this experiment, the relationship between the size of the ablated area and the stress damage probability with respect to laser energy flux can be found in Fig. 4 and Fig. 6, wherein the rate of change and threshold range of the two are essentially identical, further confirming the relationship between the probability of stress failure and the size of the ablated region.

随辐照激光能量通量降低,片状剥离的面积和几率都相应降低。通过记录 100 个辐照点发生片状剥离的次数,计算出了损伤概率随激光能量通量的变化规律,如图6所示。从图6中可以看出,激光能量通量在  $2.42 \sim 24.7 \text{ J/cm}^2$  范围内,应力损伤概率基本上随激光能量通量线性增长,损伤概率由 1% 增长到 51%。参照《光学表面激光损伤阈值测试方法 GB/T 16601-1996》,可计算在现有条件下飞秒激光单脉冲造成硅基多层膜应力损伤的阈值条件为  $2.16 \text{ J/cm}^2$ 。之前的研究结果已经表明,薄膜的破坏与激光束光斑大小的关系带有明显的几率性,光斑越大则破坏的几率越大,反之,破坏几率越小<sup>[20]</sup>。薄膜破坏的光斑效应与薄膜的杂质缺陷有关,缺陷更容易吸收激光能量导致光斑内温度场或应力场分布不均并发生优先
